005/2021

HOSPITAL
STAIRS
CONCRETE REBUILD

STAIRS REPAIR APRIL, 2013

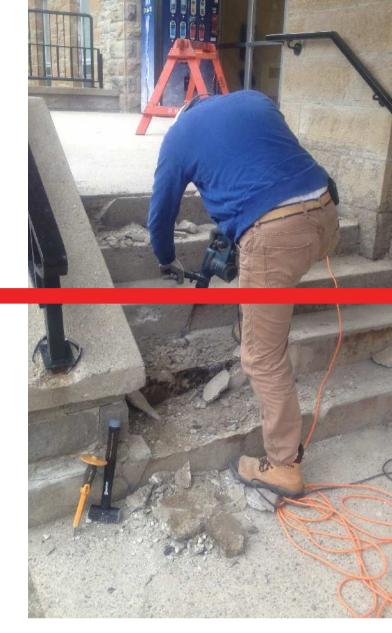
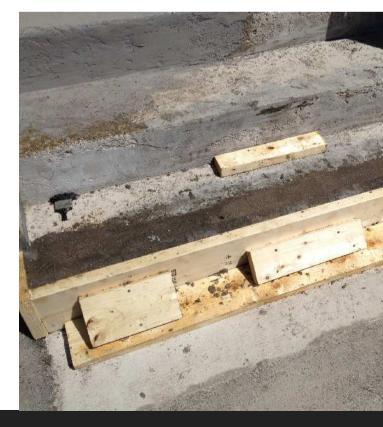
The steps had suffered severe damage and spalling caused by weathering, salt and freeze thaw effect. Large cracks and spalled stone were visible making the usage of the steps dangerous.

The damaged stone was removed back to a firm substrate. Due to the extent of the damage forms were created and Belzona 4154 (Bulkfill Resin) was mixed with locally sourced aggregate and packed into place. Once cured the forms were removed and 1/4" of Belzona 4131 (Magma-Screed) was applied over the stair treads and risers. To protect from further weathering and salt, Belzona 5231 (SG Laminate) was applied over the steps with a high visibility yellow Belzona 4411 (Granogrip) stripe at the edge of the step tread.
